CASE STUDIES
ACCIDENTS INVOLVING
WORK AT HEIGHTS

Year of Issue: 2017

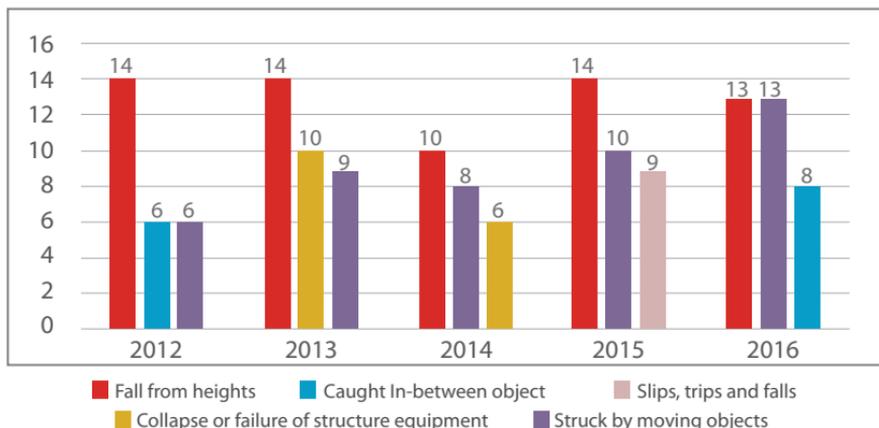
Figure 1: Fall from heights fatal injuries vs other fatal accident types.

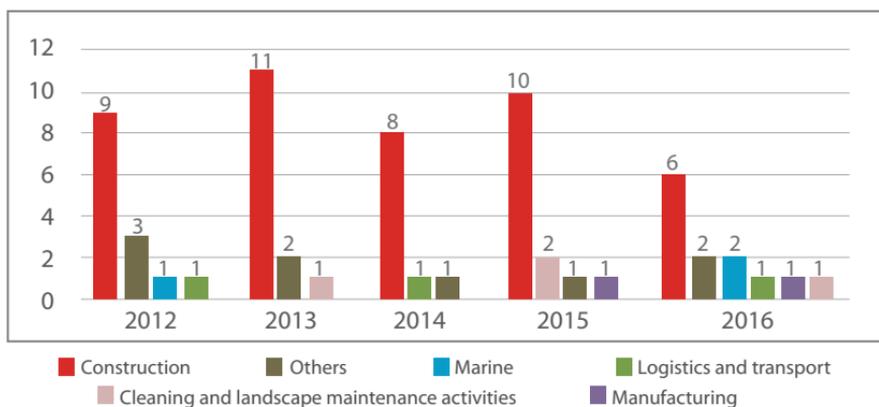
Figure 2: Fall from heights fatal injuries (by industry).

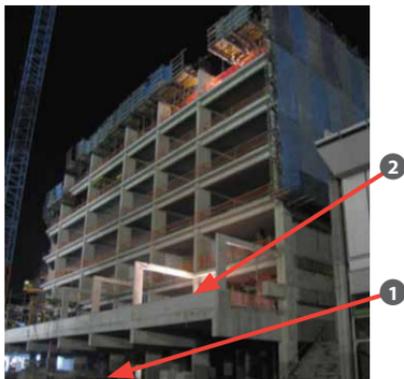
The deceased was tasked to install barricades to the open sides of a system table formwork structure. While he was standing on top of the table formwork, the structure suddenly toppled and fell over the edge of the building. The deceased landed on a protruding slab on the second floor. He was sent to the hospital where he later succumbed to his injuries.

1. Location the table formwork structure landed.
2. Location deceased landed.

Evaluation of loss	• One worker killed.
Type of contact	• Fall from heights.
Immediate cause(s)	• Worker fell together with a toppled formwork structure.
Basic cause(s)	• Failure to identify presence of incompatible work activities.
Failure of WSH management system	<ul style="list-style-type: none"> • Failure to ensure effective communication to inform relevant parties regarding incompatible works. • Failure to provide WSH training with regards to formwork.

Risk Assessment	<ul style="list-style-type: none"> Other than identifying hazards and control measures for each work activity, the RA process must also recognise presence of incompatible works. In this case, installation of barricade on the table formwork and adjustment of supporting floor props are two incompatible work activities taking place simultaneously at the same location.
Planning and coordination	<ul style="list-style-type: none"> Ensure that suitable means of communication and monitoring are in place so that work processes are carried out in the appropriate sequence. Where applicable, establish and implement a Fall Prevention Plan (FPP) and Permit-to-Work (PTW) system for all WAH activities where a worker is liable to fall. Where safety harnesses are to be used, ensure that proper and secured lifelines or anchorage points are provided for workers working at heights.
Safe Work Procedure	<ul style="list-style-type: none"> Ensure that all formwork structures are properly secured in place to prevent unwanted displacement. Ensure that no one is on top of formwork structure while adjustments are being made to its supporting floor props.

Training and awareness	<ul style="list-style-type: none"> Ensure that all personnel (including formwork supervisors and workers) involved in formwork activities have received adequate safety and health training with regards to hazards associated with construction, erection, alteration or dismantling of formwork structures. Ensure that workers understand importance of using the relevant Personal Protective Equipment (PPE) such as a safety harness.
Legislative requirements	<ul style="list-style-type: none"> Ensure that all formwork structures and related work activities complies with requirements stated in Regulation 9 of the WSH (Construction) Regulations and SS580:2012 (Code of Practice for Formwork).

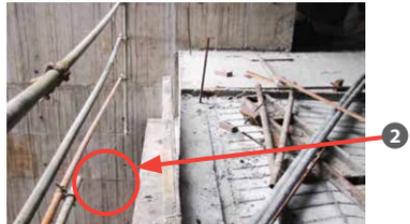
1. Location the deceased had fallen from.

2. Gap deceased fell through.

- The deceased was not wearing his safety harness which was later found in the interior of the building.

Evaluation of loss	• One worker killed.
Type of contact	• Fall from heights.
Immediate cause(s)	• Worker fell from formwork.
Basic cause(s)	• Ineffective guardrail system.
Failure of WSH management system	• Failure to ensure effectiveness of control measures. • Failure to provide adequate supervision.

Risk Assessment	<ul style="list-style-type: none">• Conduct proper RA before start of any work activity. In this case, the work activity is dismantling formwork near the edge of building. Ensure that risk control measures recommended in the RA are properly implemented and strictly adhered to.• When conducting RA, the effectiveness of existing risk control measures must be taken into consideration. In this case, it should be identified that the guardrails were not installed effectively.
-----------------	---

Planning and coordination	<ul style="list-style-type: none"> • Ensure that sufficient formwork supervisors are appointed and provided for all formwork-related activities. • Where applicable, establish and implement a Fall Prevention Plan (FPP) and Permit-to-Work (PTW) system for all WAH activities where a worker is liable to fall.
Safe Work Procedure	<ul style="list-style-type: none"> • Provide secured anchorages or lifelines at areas where safety harnesses are to be used. • Ensure that workers are educated on the importance of anchoring their safety harnesses to appropriate anchorages or lifeline at all times when working at heights.
Training and awareness	<ul style="list-style-type: none"> • Ensure that all personnel (including formwork supervisors and workers) involved in formwork activities have received adequate safety and health training with regards to hazards associated with construction, erection, alteration or dismantling of formwork structures.

Legislative requirements	<ul style="list-style-type: none"> • Ensure that guardrails are provided at all open edges where a person could fall. Guardrails must be constructed in accordance with Singapore Standards SS 567:2011 (Code of Practice for Factory Layout – Safety, Health and Welfare Consideration). • Where applicable, ensure that formwork structures (including guardrails) are constructed in accordance with PE's design and complies with requirements stated in Regulation 9 of the WSH (Construction) Regulations and SS580:2012 (Code of Practice for Formwork).

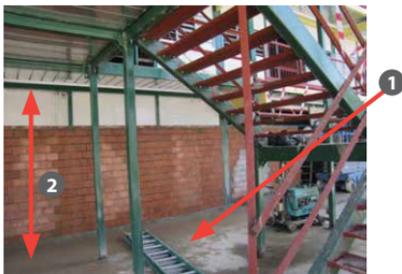
The deceased was inspecting the second level corridor of a dormitory under construction, which was scheduled to be concreted. After his inspection, while descending to the ground floor via an extension ladder, he fell with the ladder and landed on the ground. The deceased suffered head injuries and was hospitalised; he eventually passed away more than 6 months after the accident.

1. Deceased was found lying unconscious beside the ladder.
2. Height between the second level and ground is about 3.1 m.

Evaluation of loss	• One worker killed.
Type of contact	• Fall from heights.
Immediate cause(s)	• Slipping of vertical access ladder.
Basic cause(s)	• Inadequate securing of access ladder.
Failure of WSH management system	• Inadequate RA and safe work procedure (SWP) to address this specific work activity.

Risk Assessment	<ul style="list-style-type: none">• Conduct proper RA before start of any work activity. In this case, the work activity is accessing the second level using an extension ladder.• Other than identifying hazards and control measures for each work activity, the RA process must also recognise the presence of incompatible work.
Planning and coordination	<ul style="list-style-type: none">• Ensure that suitable means of communication and monitoring are in place so that work processes are carried out in the appropriate sequence.• Where applicable, establish and implement a Fall Prevention Plan (FPP) and Permit-to-Work (PTW) system for all WAH activities where a worker is liable to fall.
Safe Work Procedure	<ul style="list-style-type: none">• Ensure that an appropriate ladder is provided and used for the intended task.• Ladders used for access to another level should have at least 1 m above landing point to provide a secure handhold.• Ensure that base of ladder is secured appropriately when in use.

| Training and awareness | <ul style="list-style-type: none">• Ensure that all personnel (including workers and supervisors) involved in WAH activities have received adequate safety and health training with regards to hazards associated with working at heights.• Ensure that workers understand the importance of following recommended risk control measures with regards to use of ladders. |

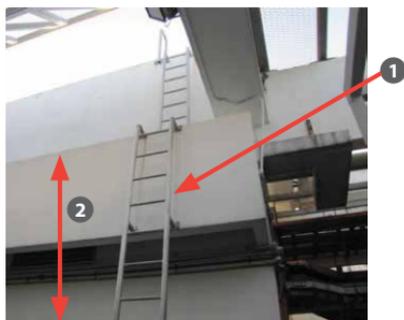
The deceased and his co-worker were tasked to install filters at existing air-conditioning units on the rooftop of a building. Upon reaching the rooftop, the co-worker climbed two fixed ladders to access the upper level of the rooftop and waited for the deceased. After waiting for about 5 minutes, the co-worker walked back to look for the deceased. He found the deceased lying on the rooftop about 1m away from the fixed ladder with a trash bag of filters beside him. The deceased was pronounced dead at the scene.

1. The first of two fixed access ladders that workers use to access the upper levels of the rooftop.
2. Height of the first vertical fixed access ladder is about 4.3 m.

- A trash bag with six pieces of filters, about 4.7 kg, was found close to the deceased.

Evaluation of loss	• One worker killed.
Type of contact	• Fall from heights.
Immediate cause(s)	• Lost footing while climbing vertical access ladder.
Basic cause(s)	• Lack of additional control measures for fixed ladders that rise a vertical distance of more than 3 m.
Failure of WSH management system	• OSHMS failed to cover maintenance activities on rooftop.

- Ensure that all personnel (including workers and supervisors) involved in WAH activities have received adequate safety and health training with regards to hazards associated with working at heights.
- Ensure that workers understand the importance of following recommended risk control measures with regards to use of fixed ladders.

- Ensure that fixed ladder complies with requirements stated in Regulation 18 of the WSH (WAH) Regulations.

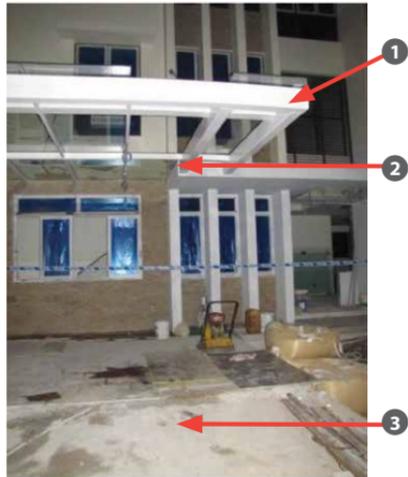
A group of workers was tasked to install glass panels on top of a car porch canopy roof. While the deceased was trying to reposition himself, he suddenly fell through an opening on the canopy roof. He was sent to the hospital and subsequently succumbed to his injuries on the same day.

1. Car porch canopy roof.
2. Opening deceased fell through.
3. Location deceased landed.

- The car porch canopy roof required installation of 12 pieces of glass panels. Installation of 11 pieces of glass panels had been completed. The last piece of glass panel had not been installed due to some defects.

- The deceased was not wearing safety helmet, safety belt or harness at the time of accident.

Evaluation of loss	<ul style="list-style-type: none">• One worker killed.
Type of contact	<ul style="list-style-type: none">• Fall from heights.
Immediate cause(s)	<ul style="list-style-type: none">• Worker fell from roof opening.
Basic cause(s)	<ul style="list-style-type: none">• Inadequate fall prevention or protection measures.• Inadequate supervision.
Failure of WSH management system	<ul style="list-style-type: none">• Failure to implement risk control measures.• Failure to ensure adherence to risk control measures.• Failure to implement PTW system for working at heights.

- Conduct proper RA before start of any work activity. In this case, the work activity is installation of glass panels on canopy roof. Ensure that risk control measures recommended in the RA are properly implemented and strictly adhered to.

Safe Work Procedure	<ul style="list-style-type: none"> • Where applicable, ensure that all openings are effectively guarded to prevent persons from falling through. In addition, a warning sign can be displayed to warn people of the hazard. • Where appropriate, if there is a risk of a worker falling through the roof, install a safety mesh or safety net (capable of preventing a person from falling through) either directly on top of or underneath the fragile roof area.
Training and awareness	<ul style="list-style-type: none"> • Ensure that all personnel (including workers and supervisors) involved in WAH activities have received adequate safety and health training with regards to hazards associated with WAH. • Ensure that workers understand the importance of following recommended risk control measures. Highlight need for workers to anchor their fall arrest safety harnesses to secured lifeline or anchor points at all times when working at heights. Whenever appropriate, consider use of twin lanyard harnesses and 100% tie-off (i.e., at least one lanyard is anchored to a lifeline at any time).

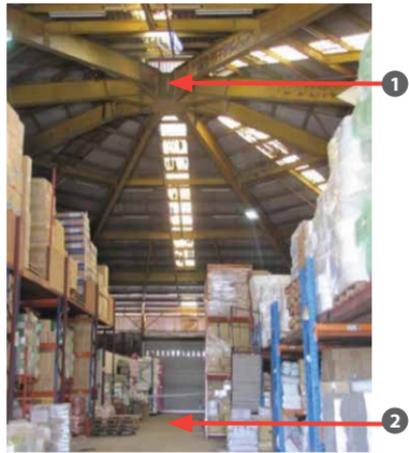
The deceased had accessed the roof of a warehouse using a tower scaffold. While walking on the roof he had most likely stepped on a fibreglass skylight panel, which gave way under his weight, and fell to the ground. He was pronounced dead at the scene by attending paramedics.

1. Roof skylight deceased had fallen through.
2. Location deceased landed.

- The deceased was not wearing any fall arresting device while he was on the roof.

Evaluation of loss	<ul style="list-style-type: none"> • One worker killed.
Type of contact	<ul style="list-style-type: none"> • Fall from heights.
Immediate cause(s)	<ul style="list-style-type: none"> • Worker fell through roof skylight opening.
Basic cause(s)	<ul style="list-style-type: none"> • Lack of WSH-related training while working at heights and proper identification of hazards in the vicinity.
Failure of WSH management system	<ul style="list-style-type: none"> • Failure to provide adequate training so that workers may perform their work safely. • Failure to ensure that only competent persons were engaged to carry out roof survey works. • Failure to provide any form of fall prevention or protection control measures.

Risk Assessment	<ul style="list-style-type: none"> • Conduct proper RA before start of any work activity. In this case, the work activity is roof survey works. Ensure that risk control measures recommended in the RA are properly implemented and strictly adhered to.
Planning and coordination	<ul style="list-style-type: none"> • Ensure that a proper safe work method is established for working on roofs with consideration of the roof's characteristics (e.g., roof material, profile, slope and height) as well as the duration and frequency of work. • If fall arrest system is to be used, check for existence and suitability of all lifeline and anchor points prior to the start of relevant work activity.

- Ensure that all lifeline and anchor points are installed and tested in accordance to SS 570: 2011 Personal protective equipment for protection against falls from height – Single point anchor devices and flexible horizontal lifeline systems.
- Ensure that adequate and suitable supervision is provided for all WAH activities.
- Where applicable, it is recommended to establish and implement a Fall Prevention Plan (FPP) and Permit-to-Work (PTW) system for all WAH activities where a worker is liable to fall.

- Where applicable, ensure that all openings are effectively guarded to prevent persons from falling through. In addition, a warning sign can be displayed to warn people of the hazard.
- Where appropriate, if there is a risk of a worker falling through the roof, install a safety mesh or safety net (capable of preventing a person from falling through) either directly on top of or underneath fragile roof area.

- Training and awareness
- Ensure that all personnel (including workers and supervisors) involved in WAH activities have received adequate safety and health training with regards to hazards associated with working at heights.
 - Ensure that workers understand the importance of following recommended risk control measures. Highlight need for workers to anchor their fall arrest safety harnesses to secured lifeline or anchor points at all times when working at heights. Whenever appropriate, consider use of twin lanyard harnesses and 100% tie-off (i.e., at least one lanyard is anchored to a lifeline at any time).
- Legislative requirements
- Ensure that all WAH activities are carried out in accordance with requirements stipulated in the WSH (WAH) Regulations.

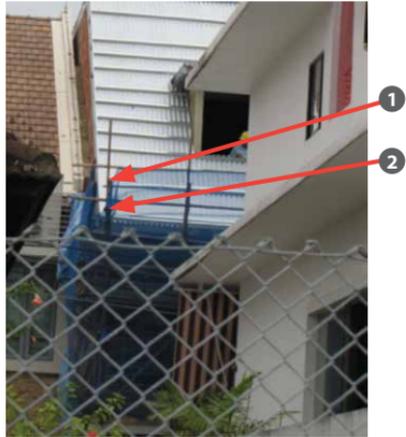
The deceased and four other workers were tasked to carry out roof works for a building under construction. The deceased was laying aluminium sheets over a sloping roof when he suddenly lost his footing and fell to the ground. He was sent to the hospital and subsequently succumbed to his injuries.

1. Location the deceased most likely fell from.
2. Bent Z-angle bracket.

- At the location where the deceased had most likely fallen from, a bent Z-angle bracket (see picture on left) was observed to be not bolted to the roof sheets. It was probable that the deceased had lost his balance when he stepped on the unsecured Z-angle bracket while laying the aluminium sheet.

Evaluation of loss	<ul style="list-style-type: none"> • One worker killed.
Type of contact	<ul style="list-style-type: none"> • Fall from heights.
Immediate cause(s)	<ul style="list-style-type: none"> • Worker fell off sloping roof.
Basic cause(s)	<ul style="list-style-type: none"> • Failure to implement fall prevention risk control measures effectively.
Failure of WSH management system	<ul style="list-style-type: none"> • Failure to ensure effective implementation of fall prevention risk control measures so that workers may perform their work safely. • Failure to provide adequate supervision.

Risk Assessment	<ul style="list-style-type: none">• Conduct proper RA before start of any work activity. In this case, the work activity is roof installation works. Ensure that risk control measures recommended in the RA are properly implemented and strictly adhered to.
Planning and coordination	<ul style="list-style-type: none">• If fall arrest system is to be used, check for existence and suitability of all lifeline and anchor points prior to the start of roof works.• Ensure that a proper safe work method is established for working on roofs with consideration of the roof's characteristics (e.g., roof material, profile, slope and height) as well as the duration and frequency of work.• Ensure that all lifeline and anchor points are installed and tested in accordance to SS 570: 2011 Personal protective equipment for protection against falls from height – Single point anchor devices and flexible horizontal lifeline systems.• Ensure that adequate and suitable supervision is provided for all WAH activities.• Ensure effective implementation of the Fall Prevention Plan (FPP) and PTW systems.

Edge protection	<ul style="list-style-type: none">• Ensure that edge protection is provided wherever a person is at risk of falling from open sides.• In the case of guardrails system, they must be of good construction, in good condition and be able to withstand the weight of a person (at least 100kg, SS 567:2011 – Code of Practice for factory layout – Safety, health and welfare considerations) applied in any direction at any point.

Safe access and egress	<ul style="list-style-type: none"> • If work on top of a roof is unavoidable, careful planning is required to provide safe and proper means (e.g., by erecting scaffold access) for workers to get to and exit from rooftop work location. • For safer access and work on fragile roofs, the use of crawl boards and roof ladders should be deployed to prevent workers from stepping directly on surface of fragile roof.
Training and awareness	<ul style="list-style-type: none"> • Ensure that workers understand the importance of following recommended risk control measures. Highlight need for workers to anchor their fall arrest safety harnesses to secured lifelines or anchor points at all times when working at heights. Whenever appropriate, consider use of twin lanyard harnesses and 100% tie-off (i.e., at least one lanyard is to be anchored to the lifeline at any time). • Ensure that all personnel (including workers and supervisors) involved in WAH activities have received adequate safety and health training with regards to hazards associated with working at heights.

Legislative requirements	<ul style="list-style-type: none"> • Ensure that all WAH activities are carried out in accordance with requirements stipulated in the WSH (WAH) Regulations.

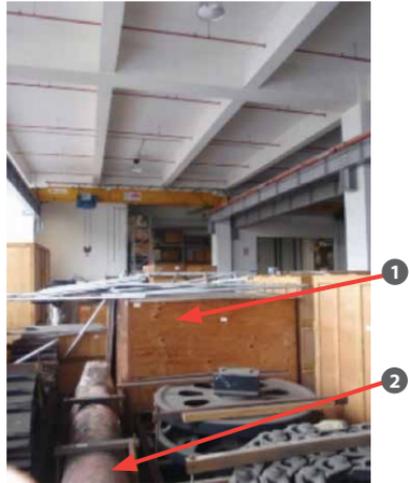
Two workers erected a tower scaffold on top of a wooden crate to replace faulty overhead light bulbs. After replacing an overhead light bulb, the deceased proceeded to dismantle the scaffold when one of the scaffold member got stuck. He started to kick the stuck scaffold member and in the process lost his balance, fell and struck his head against a steel pipe structure on the ground. He was sent to the hospital and subsequently succumbed to his injuries.

1. Wooden crate tower scaffold was erected on.
2. Steel pipe structure deceased head struck against.

- Prior to the fall, the deceased was observed to have removed his safety harness and helmet.

- The area beneath the high bay light was observed to be congested with wooden crates and equipment.

Evaluation of loss	<ul style="list-style-type: none">• One worker killed.
Type of contact	<ul style="list-style-type: none">• Fall from heights.
Immediate cause(s)	<ul style="list-style-type: none">• Adopting unsafe work method of dismantling scaffold.• Scaffold was erected on unstable surface.
Basic cause(s)	<ul style="list-style-type: none">• Unsafe and congested work environment.
Failure of WSH management system	<ul style="list-style-type: none">• Failure to provide relevant scaffold-related training.• Failure to conduct effective RA .

Risk Assessment	<ul style="list-style-type: none">• Conduct proper RA before start of any work activity. In this case, the work activity is erecting and dismantling of scaffold for changing of high bay lights.
Planning and coordination	<ul style="list-style-type: none">• Ensure good housekeeping to prevent obstruction and create a safe environment. In this case, good housekeeping should be ensured before erecting the tower scaffold for changing of high bay lights.• Where applicable, it is recommended to establish and implement a Fall Prevention Plan (FPP) and Permit-to-Work (PTW) system for all WAH activities where a worker is liable to fall.

<ul style="list-style-type: none"> • Where applicable, it is recommended to establish and implement a Fall Prevention Plan (FPP) and Permit-to-Work (PTW) system for all WAH activities where a worker is liable to fall.
Safe Work Procedure	<ul style="list-style-type: none"> • Ensure that all scaffolds are erected on a firm and stable ground to prevent toppling.
Training and awareness	<ul style="list-style-type: none"> • Ensure that all personnel (including workers and supervisors) involved in WAH activities have received adequate safety and health training with regards to hazards associated with working at heights. • Ensure that scaffolds are only erected and dismantled by a trained, competent and authorised personnel. • Ensure that workers understand the importance of using the relevant Personal Protective Equipment (PPE).
Legislative requirements	<ul style="list-style-type: none"> • Ensure that all scaffolds and their components meet requirements stipulated in the WSH (Scaffolds) Regulations.

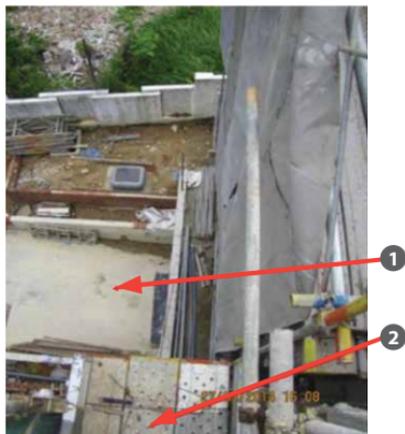
The deceased was making preparations to extend a work platform. Another worker witnessed that he removed the anchorage of his safety harness from the scaffold frame, and walked towards the open edge where he lost his balance and fell over the edge of the scaffold. He fell from a height of about 10m and landed on the ground below. He succumbed to his injuries on the spot.

1. Location deceased worker was found after the accident.
2. Platform deceased worker was last seen before the accident.

- An open side was observed on transverse side of the external scaffold, after the deceased removed the guardrail.

Evaluation of loss	<ul style="list-style-type: none"> • One worker killed.
Type of contact	<ul style="list-style-type: none"> • Fall from heights.
Immediate cause(s)	<ul style="list-style-type: none"> • Worker fell from an open side at the transverse side of the external scaffold.
Basic cause(s)	<ul style="list-style-type: none"> • Failure to provide adequate SWP. • Failure to ensure safety harness is anchored.
Failure of WSH management system	<ul style="list-style-type: none"> • Failure to ensure effective implementation of PTW system.

Risk Assessment	<ul style="list-style-type: none"> • Conduct proper RA before start of any work activity. In this case, the work activity is installation of extended work platform on transverse side of the external scaffold. The RA should also identify hazards associated with scaffold modification process.
Planning and coordination	<ul style="list-style-type: none"> • Where applicable, it is recommended to establish and implement PTW system for all WAH activities where a worker is liable to fall.

Safe Work Procedure	<ul style="list-style-type: none"> • When guardrails need to be removed for modification of scaffold, the erector must maintain a 100% tie-off while working. • Safety harnesses must be anchored at all times while working at heights. • All scaffold works must be supervised by a competent scaffold supervisor at all times.
Training and awareness	<ul style="list-style-type: none"> • Ensure that all personnel (including workers and supervisors) involved in WAH activities have received adequate safety and health training with regards to hazards associated with working at heights. • Ensure that workers understand the importance of deploying 100% tie-off when working near open edge.
Legislative requirements	<ul style="list-style-type: none"> • Assess all lifeline and anchor points for suitability and security before use. Ensure that all lifeline and anchor points are installed and tested in accordance with SS 570: 2011 Personal protective equipment for protection against falls from height – Single point anchor devices and flexible horizontal lifeline systems. • Ensure that all scaffolds and related activities meet requirements stipulated in the WSH (Scaffolds) Regulations.

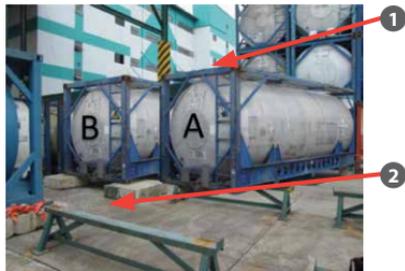
The deceased was preparing an ISO tank ("Tank A") for testing at the designated periodic test area. Tank A was placed next to another ISO tank ("Tank B"). The deceased was working on top of Tank A and then jumped across to Tank B. Upon landing on the top of Tank B, the deceased lost his balance and fell to the ground. The deceased was sent to the hospital where he later succumbed to his injuries.

1. Deceased jumped from the top of Tank A to the top of Tank B.
2. Position of deceased after he lost his balance and fell from the top of Tank B.

- The management have failed to provide lifelines at the accident scene.

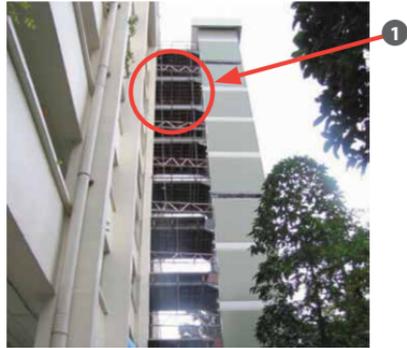
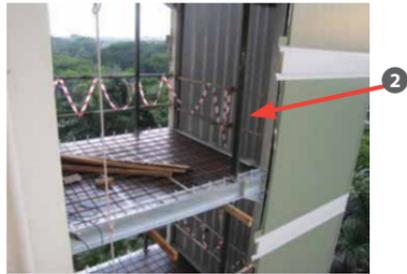
Two workers were tasked to weld some steel hollow sections at a lift landing on the fifth floor of a building. The deceased was lowering an electrical cable from the eighth floor when he fell over the edge of the lift landing and landed on the first floor. The two guardrails which were used to guard the open side at the lift landing on the eighth floor were also found on the first floor. He was pronounced dead at the scene by attending paramedics.

1. Eighth storey lift landing the deceased fell from.
2. Open side of eighth storey lift landing (guardrails were found at the first storey after the accident).

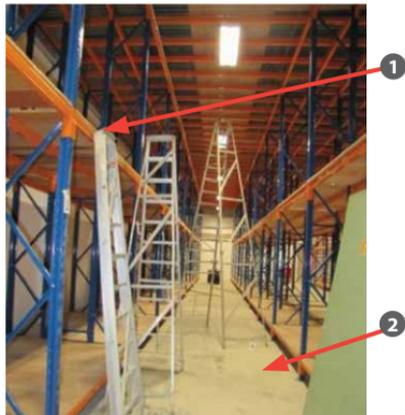
The deceased was standing on the second tier of a storage rack in a warehouse. He was likely to be reaching out to an A-frame ladder to descend from the second tier of a storage rack to the warehouse floor when he lost his balance and fell off the edge of the rack. He succumbed to his injuries on the same day.

1. Location deceased was last seen.

2. Location deceased had landed.

Risk Assessment	<ul style="list-style-type: none">• Conduct proper RA before start of any work activity. In this case, the work activity is use of ladders. Ensure that risk control measures recommended in the RA are properly implemented and strictly adhered to.
Safe Work Procedure	<ul style="list-style-type: none">• Ensure that an appropriate ladder is provided and used for the intended task. For example, ladder must be high enough for a worker to reach his work area without having to stretch and stand on its top rung.• Ladders used for access to another level should have at least 1 meter above landing point to provide a secured handhold.• Ensure that base of ladder must be appropriately secured when in use.

<ul style="list-style-type: none"> • Ensure that all ladders are maintained and stored in accordance with manufacturer's instructions. Damaged ladders must not be used. • Ensure that all ladders are used on firm and stable ground to prevent toppling.
Training and awareness	<ul style="list-style-type: none"> • Ensure that all personnel (including workers and supervisors) involved in WAH activities have received adequate safety and health training with regards to hazards associated with working at heights. • Ensure that workers understand the importance of following recommended risk control measures with regards to use of ladders.
Legislative requirements	<ul style="list-style-type: none"> • Ensure that all ladders and their use meet requirements stipulated in the WSH (WAH) Regulations.

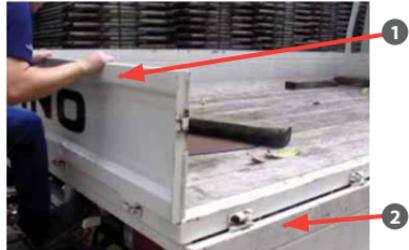
The deceased was using foot support located at the back of lorry to climb down from lorry bed while holding onto the back tailboard as support leverage when the tailboard gave way. He fell backwards onto the ground and hit the back of his head. The lorry driver succumbed to his injuries on the same day.

1. Back tailboard of the lorry.
2. Right panel board of the lorry that was in unlock position.
